Service History of the F-111 Wing
Pivot Fitting Upper Surface
Boron/Epoxy Doublers

DSTO-TN-0168

**Airframes and Engines Division
Aeronautical and Maritime Research Laboratory**

September 1998

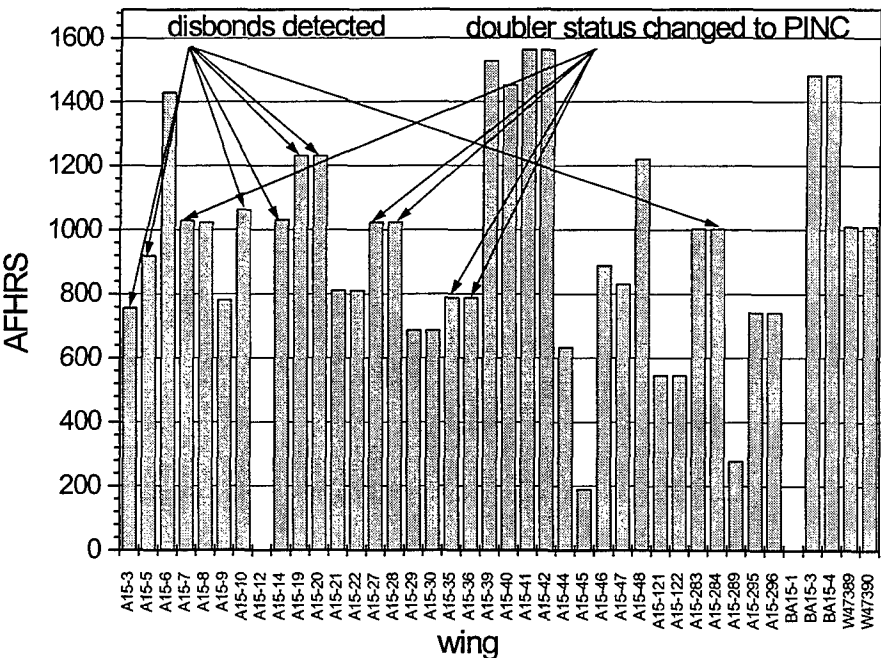
Most of the RAAF wings with doublers have seen between 4100 and 6100 hours of service. Since the application of the doublers, the wings have seen between 193 and 1565 hrs of service with the majority falling between 500 and 1500 hrs of service (Fig 1.)

Figure 1. Hours of service of boron doublers since fitment.

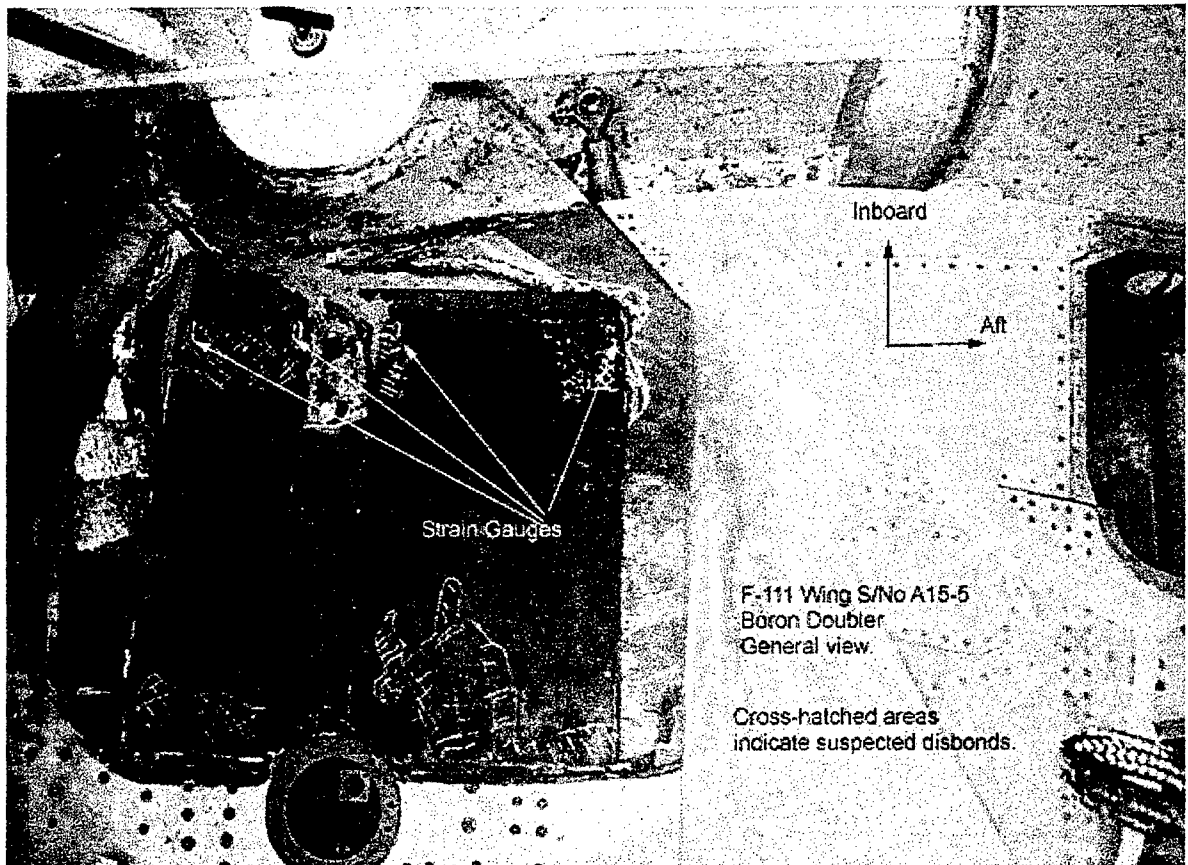
Figure 7 below shows the AMRL ultrasonic inspection results for the A15-5 doublers. Disbonds indicated by white crosshatched region.

Figure 7. Results from AMRL ultrasonic inspection – ref F-111/Wing/01.
